WINTECH
TESTING & CERTIFICATION
by UL

Technical Report – R20605 PAS 24:2016 - Enhanced security performance requirements for doorsets and windows in the UK

**Smart Systems Ltd
Double Doors- Open In**

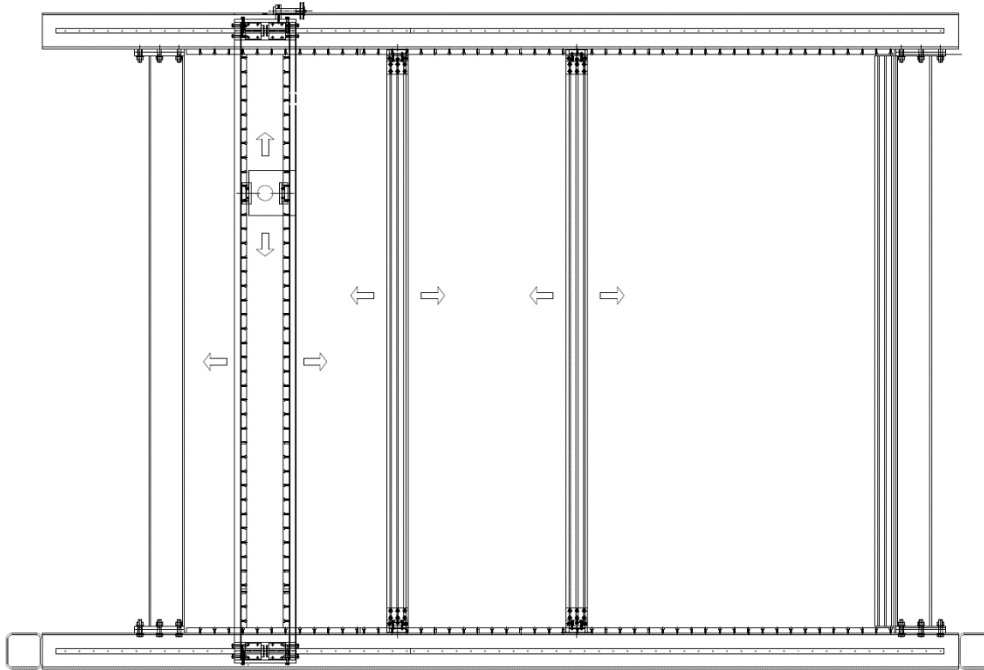
Figure 1 – Test rig used for testing

The test sample was supplied mounted in 100 x 50 mm timber sub-frame in accordance with manufacturer's installation requirements. It was fitted into the test rig, shown below which was constructed to meet the requirements of the test specification and was fitted plumb, square and without twist or bends.

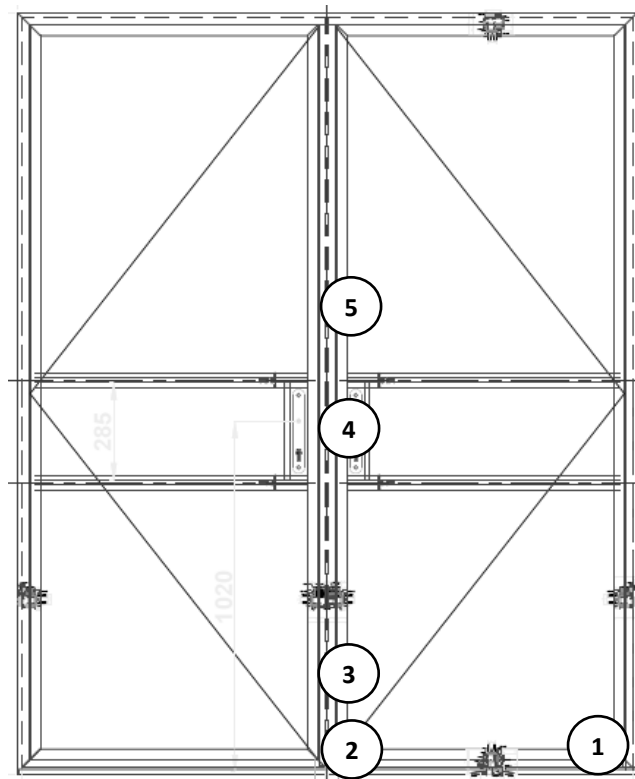
Figure 2 – Attack locations

Attempts were made from the external face to operate, release and disengage the system hardware in order to gain entry through the sample in accordance with Section C.4.3 of PAS 24:2016. The results are as follows:

Location	Tools Used	Method	Time
Point 1 – Hinge/ dog bolt	2 paint scrapers	Used 2 paint scrapers in an attempt to manipulate the hinge/dogbolt. No entry gained.	03:00
Point 2 – Shoot bolt	2 paint scrapers	Used 2 paint scrapers in an attempt to manipulate the shoot bolt. No entry gained.	03:00
Point 3 - Cam	2 paint scrapers	Used 2 paint scrapers in an attempt to manipulate the cam. No entry gained.	03:00
Point 4 – Dead bolt	2 paint scrapers	Used 2 paint scrapers in attempt to manipulate the dead bolt. No entry gained.	03:00
Point 5 - Cam	2 paint scrapers	Used 2 paint scrapers in attempt to manipulate the cam. No entry gained.	03:00

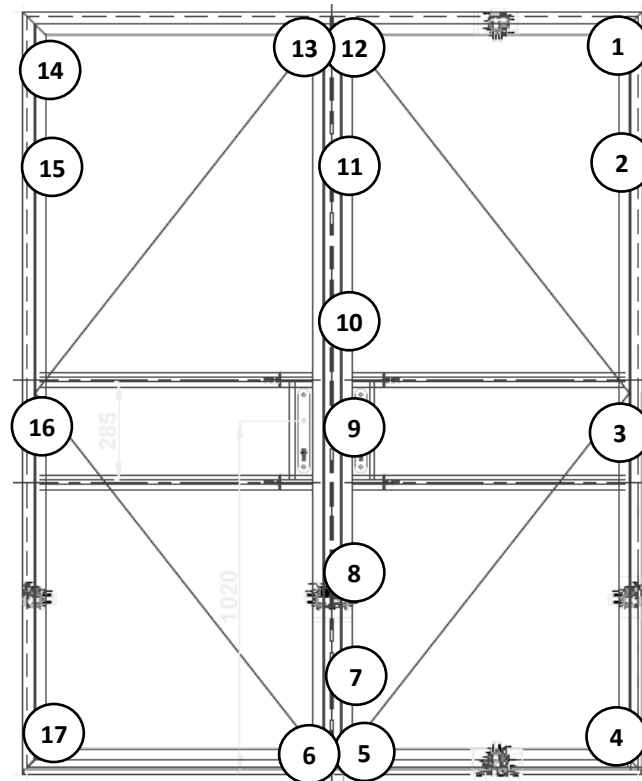
Figure 3 – Loading points

A series of loads were applied to the internal face of the sample as defined in Section B.4.5 of PAS 24:2016. The loading combinations used were as defined in Table B.1 to Table B.6 of PAS 24:2016 for the applicable door type and as shown in Table 2. The results are as follows:

Loading Point	Parallel-to-plane Load		Perpendicular-to-plane Load		Result
	Load	Direction	Load	Direction	
1 – Hinge/dog bolt	1.5	←	4.5	-	Pass
2 – Hinge/dog bolt	1.5	←	4.5	-	Pass
3 – Hinge/dog bolt	1.5	←	4.5	-	Pass
4 – Hinge/dog bolt	1.5	←	4.5	-	Pass
5 – Shoot bolt	1.5	↑	4.5	-	Pass
6 – Shoot bolt	1.5	↑	4.5	-	Pass
7 – Cam	1.5	↑	4.5	-	Pass
7 – Cam	1.5	↔	4.5	-	Pass
8 – Cam	1.5	↑	4.5	-	Pass
8 – Cam	1.5	↔	4.5	-	Pass
9 – Dead bolt	1.5	↔	4.5	-	Pass
10 – Cam	1.5	↑	4.5	-	Pass
10 – Cam	1.5	↔	4.5	-	Pass
11 – Cam	1.5	↑	4.5	-	Pass
11 – Cam	1.5	↔	4.5	-	Pass
12 – Shoot bolt	1.5	↓	4.5	-	Pass
13 – Shoot bolt	1.5	↓	4.5	-	Pass
14 - Hinge/dog bolt	1.5	→	4.5	-	Pass
15 - Hinge/dog bolt	1.5	→	4.5	-	Pass
16 - Hinge/dog bolt	1.5	→	4.5	-	Pass
17 - Hinge/dog bolt	1.5	→	4.5	-	Pass

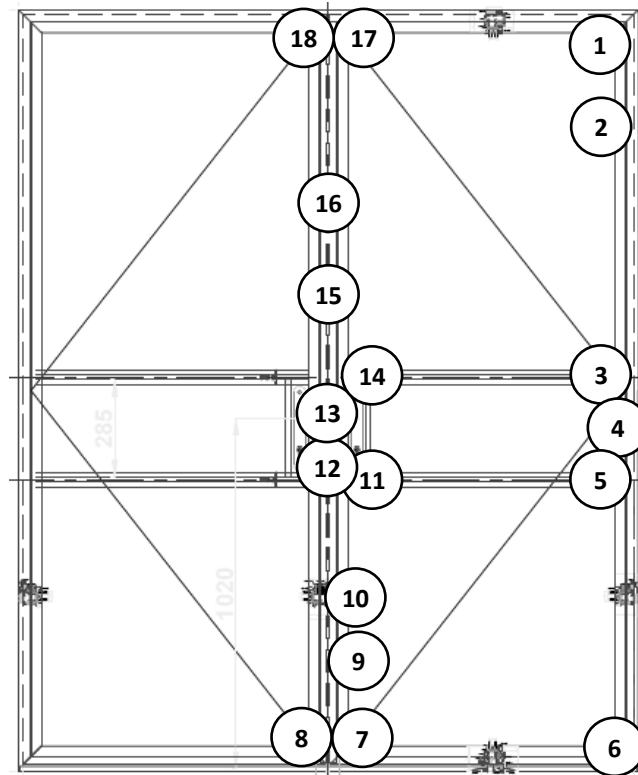
Figure 5 – Impact locations

The test sample was subject to hard body impacts on the external face as shown in Figure 5. Each of the impact locations was subject to 3 impacts from a drop height of 165 mm following which no entry was gained through the sample.
