# Test Report 8421006.

## Smart Systems Limited incorporating Smart Extrusions

Eco Futural Aluminium Alloy Double Doors

BS4873/PAS24 Type Test

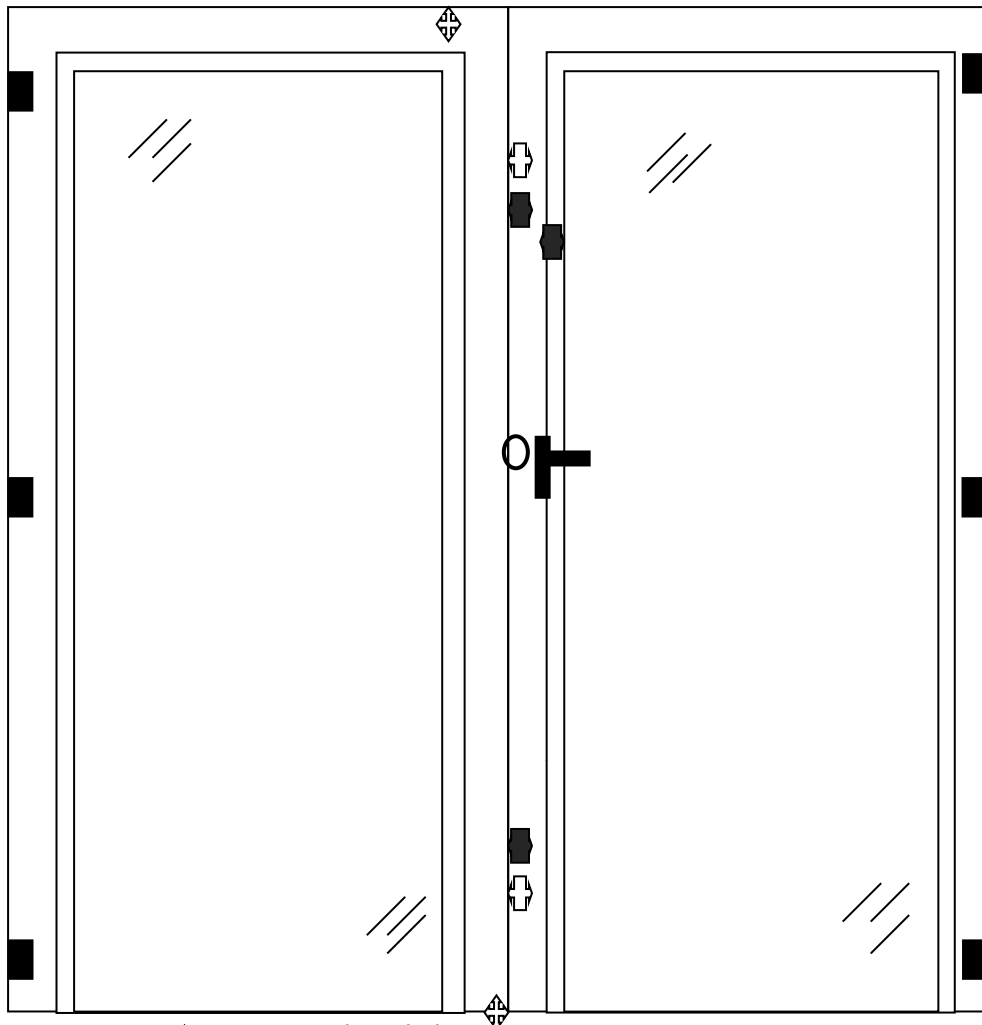
**ELEVATION DRAWING OF DOOR ASSEMBLY  
(indicating position of hardware)**

- shoot bolt
-

- handle
-

- dead bolt
-

- hook bolt
-

- Lift off hinges
-

- Hook bolt / Dead bolt

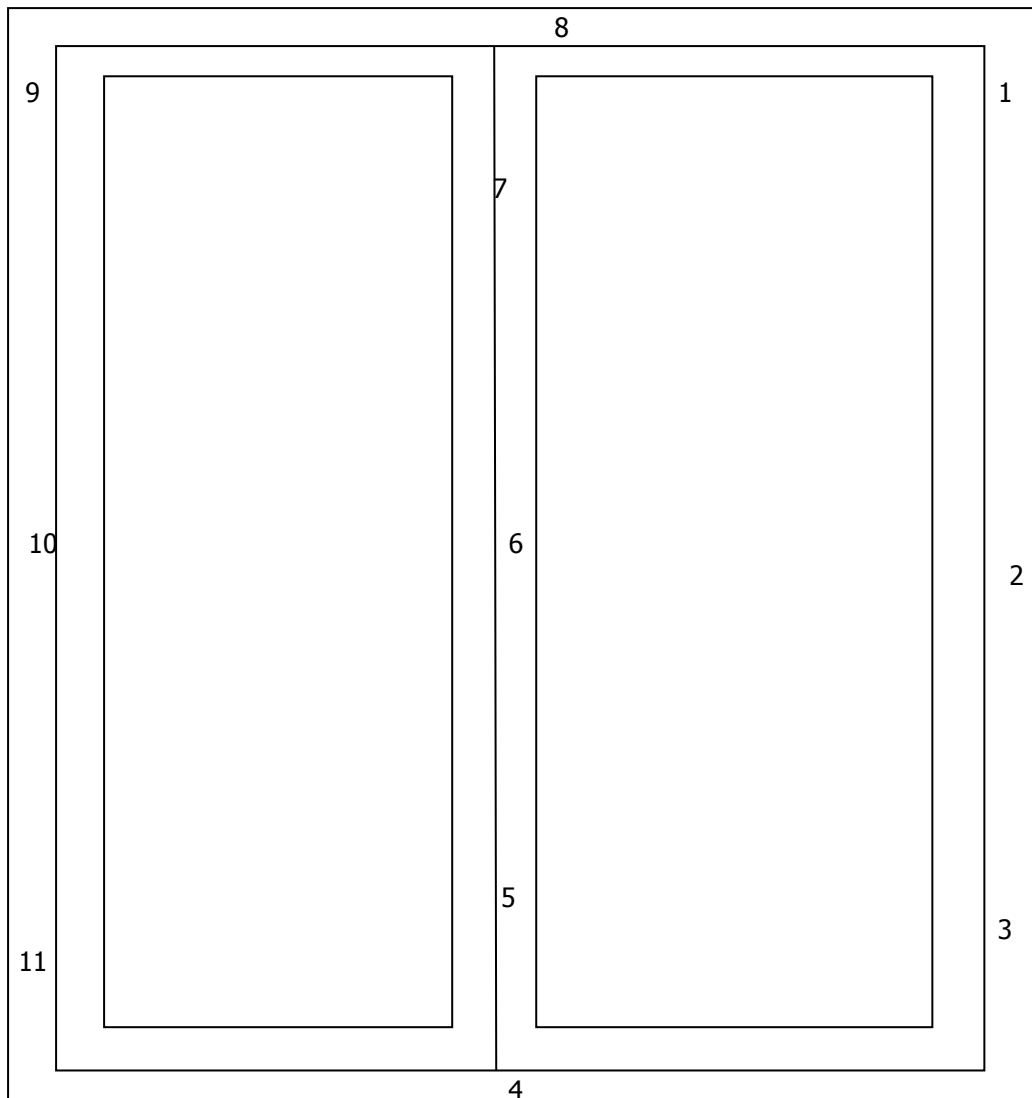
Diagram of points of application of loads

The test was carried out in accordance with the procedures detailed in B.4.5, Using loading cases B.1 to B.6 and Figures B.12 for loading sequence and using the test apparatus detailed in Figures B.6 to B.9.

1. Hinge (upper right jamb)

4. Shoot bolt (threshold of slave leaf)

5. Hook bolt/Bolt (lower locking jambs)

8. Shoot bolt (head of slave leaf)

9. Hinge (upper left jamb)

No entry effected

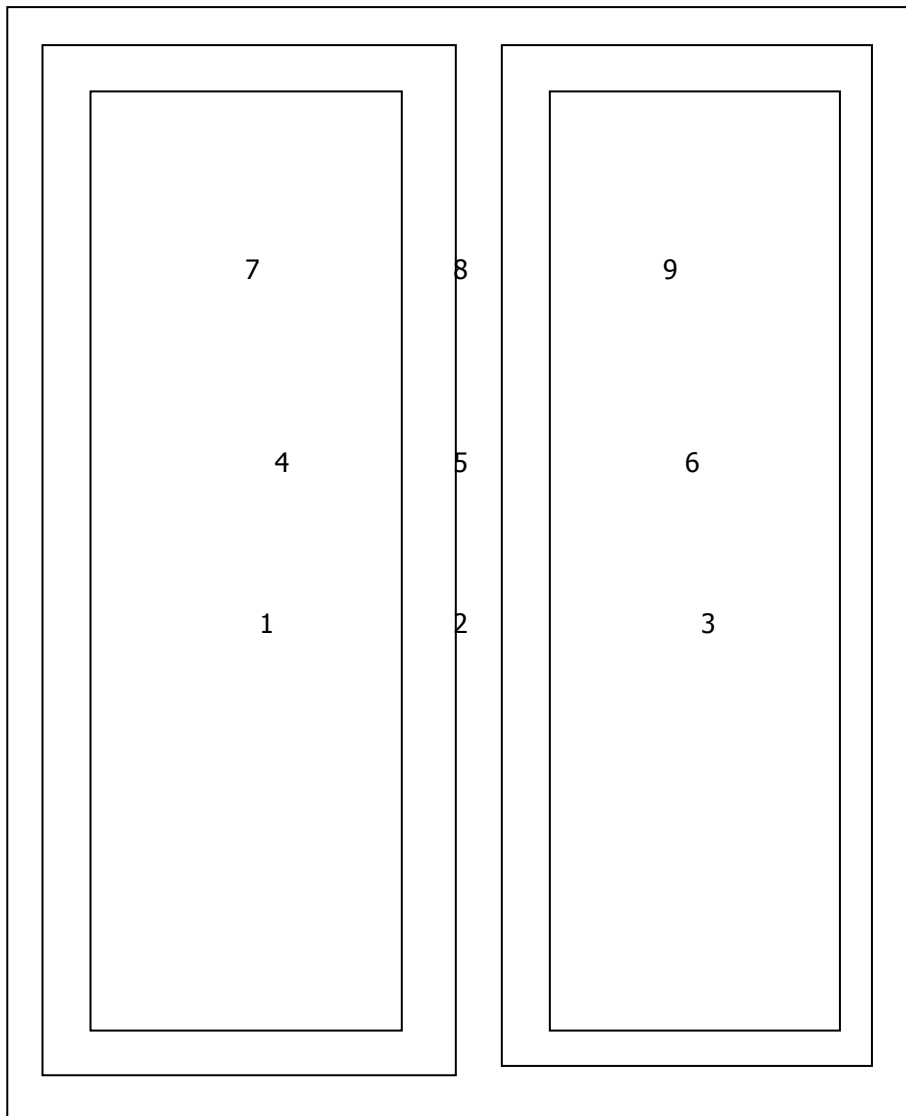
Diagram of points of application of loads

The test was carried out in accordance with the requirements, objectives and procedures detailed in B.4.8.1 using the impact point and procedure described in B.4.8.2 and B.4.8.3 and Figure B.10

Impact point	Position from floor level	Effect
1	0.80m Master	None
2	0.80m False mullion	None
3	0.80m Slave	None
4	1.25m Master	None
5	1.25m False mullion	None
6	1.25m Slave	None
7	1.7m Master	None
8	1.7m False mullion	None
9	1.7m Slave	None

No entry effected

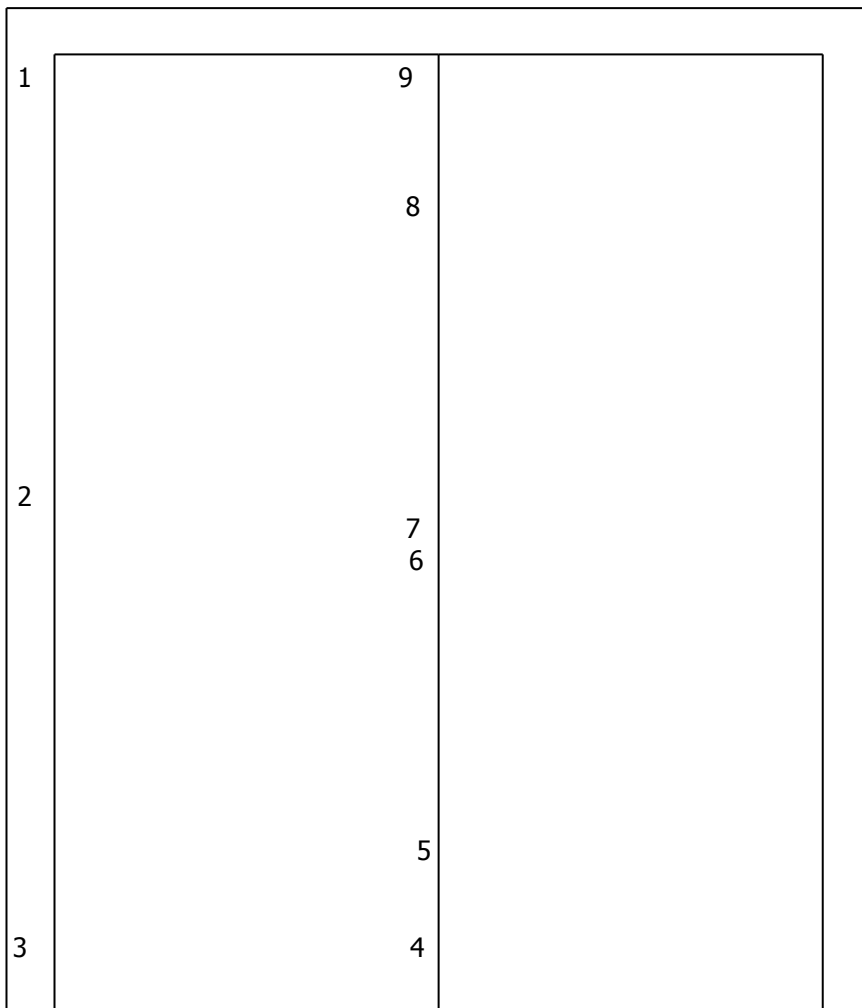
Diagram of points of application of loads

The test was carried out in accordance with the requirements, objectives and procedures detailed in B.4.9.1, B.4.9.2.1, B.4.9.2.2, B.4.9.2.3 using procedure B.4.9.3, using the test apparatus detailed in B.11 using the impact sequence in figure B.14.

Impact point	Position	Effect
1	Corner/Hinge	None
2	Hinge	None
3	Corner/Hinge	None
4	Corner/Shootbolt	None
5	Hook bolt/Dead bolt / Deadbolt	None
6	Cylinder	None
7	Hook bolt	None
8	Hook bolt/Dead bolt / Deadbolt	None
9	Corner/Shootbolt	None

No entry effected

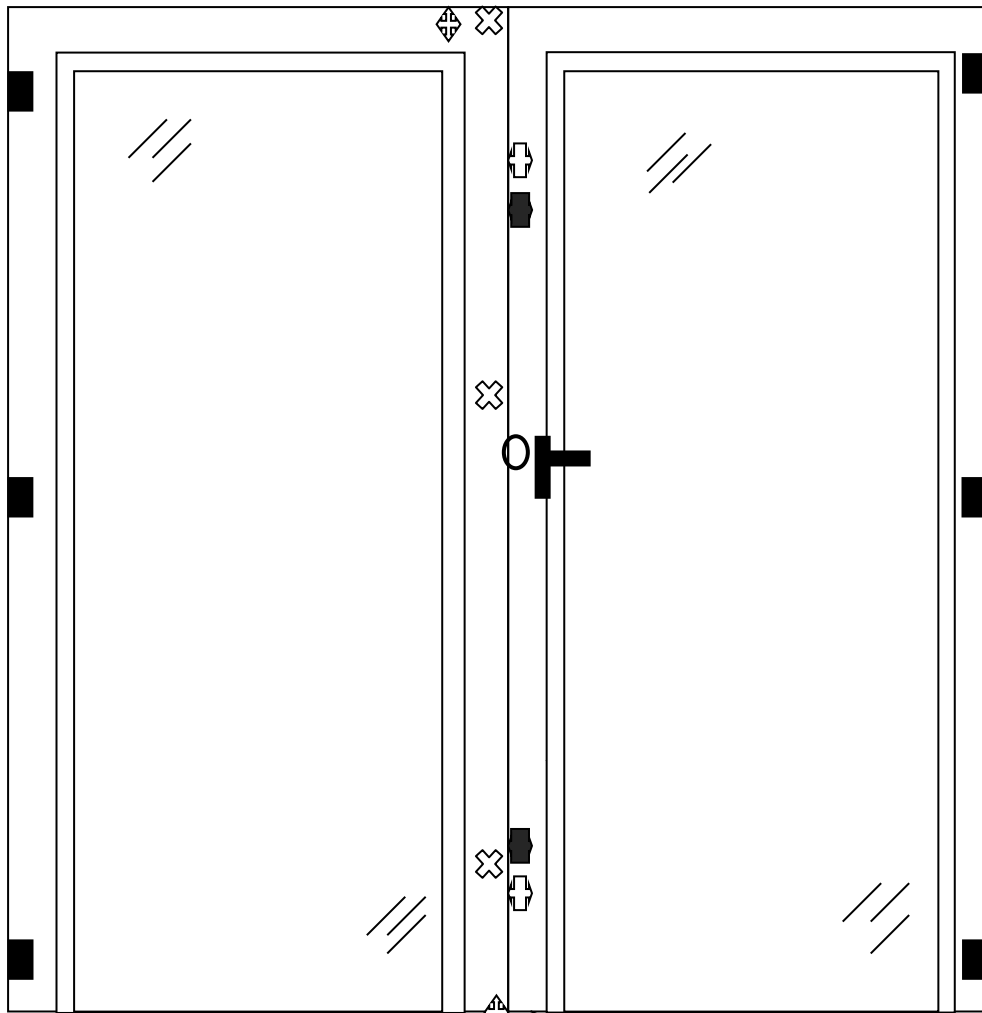
**ELEVATION DRAWING OF DOOR ASSEMBLY  
(indicating position of hardware)**

- Hook bolt / Dead bolt
- Water Leakage

Air pressure (Pa)	Point at which water leakage occurred
200	water ran out and over from the threshold opening joint (false mullion)

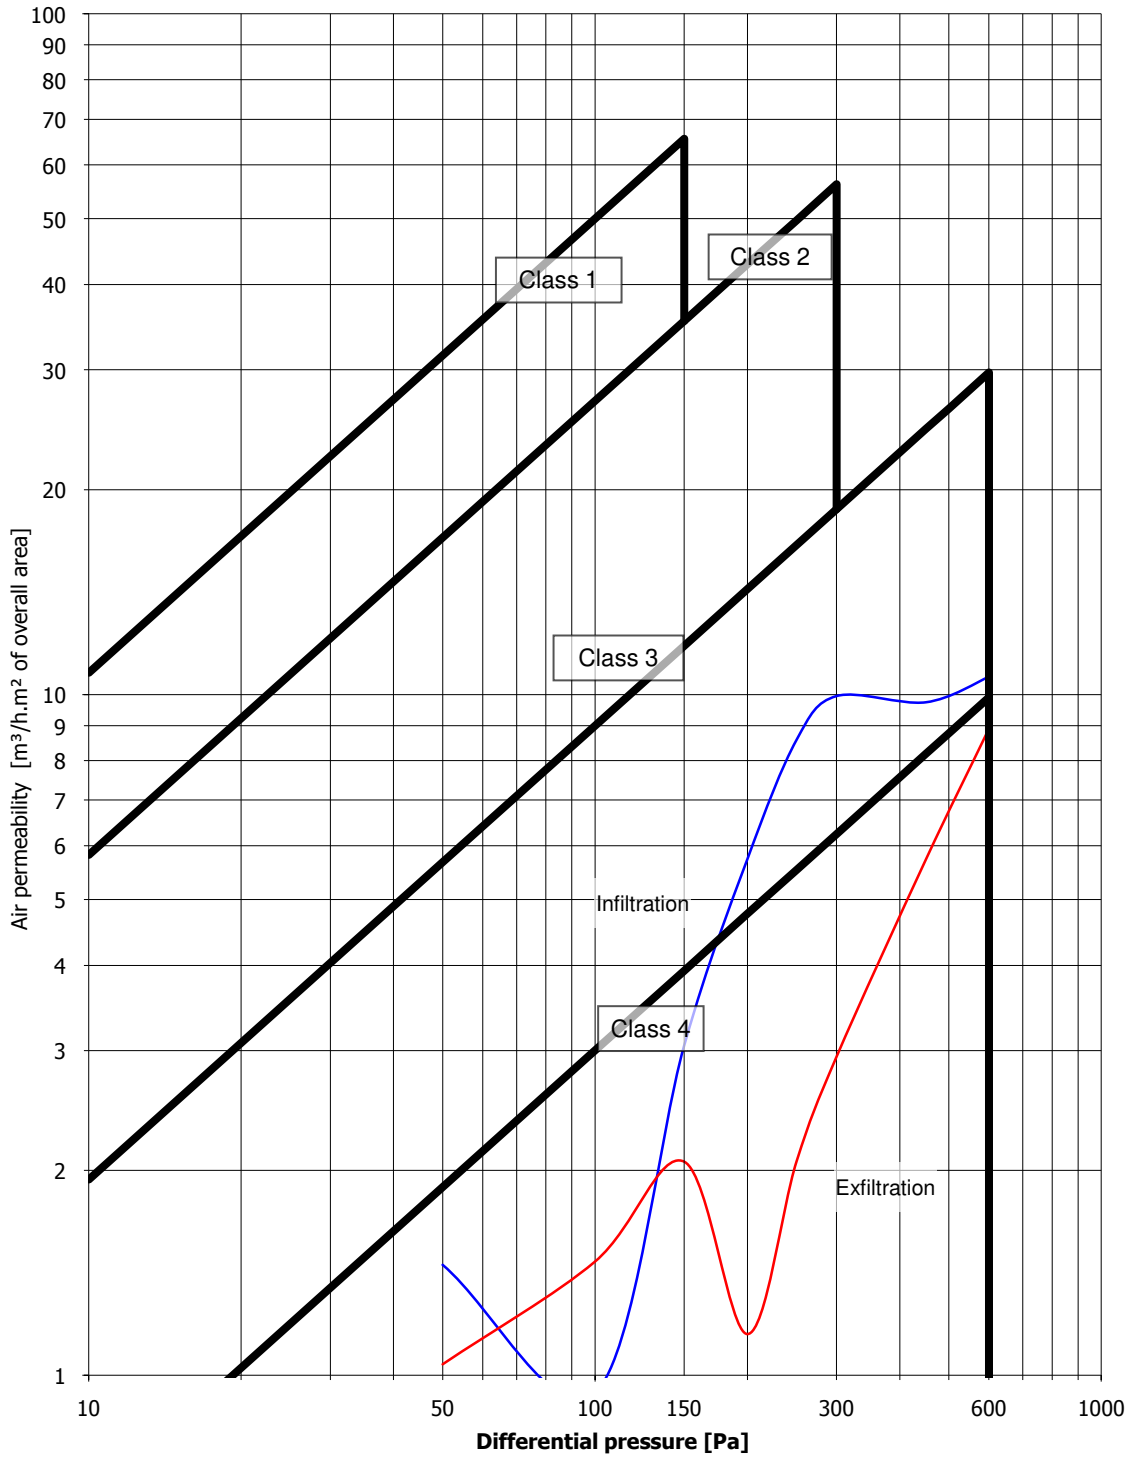
**GRAPH OF AIR PERMEABILITY BEFORE GUSTING**

Air Pressure [Pa]	Average rate of air leakage [m <sup>3</sup> /h]	Average rate of air leakage relative to area of sample [m <sup>3</sup> /h.m <sup>2</sup> ]
50	7.7	1.2
100	7.5	1.2
150	15.8	2.6
200	21.3	3.4
250	33.0	5.3
300	40.0	6.4
450	47.9	7.7
600	60.5	9.8

Note: The figures in the table above give the leakage as an average of the leakage at positive pressure and the leakage at negative pressure

BS 6375-1:2009 Clause 6.2 - Overall area class = 3

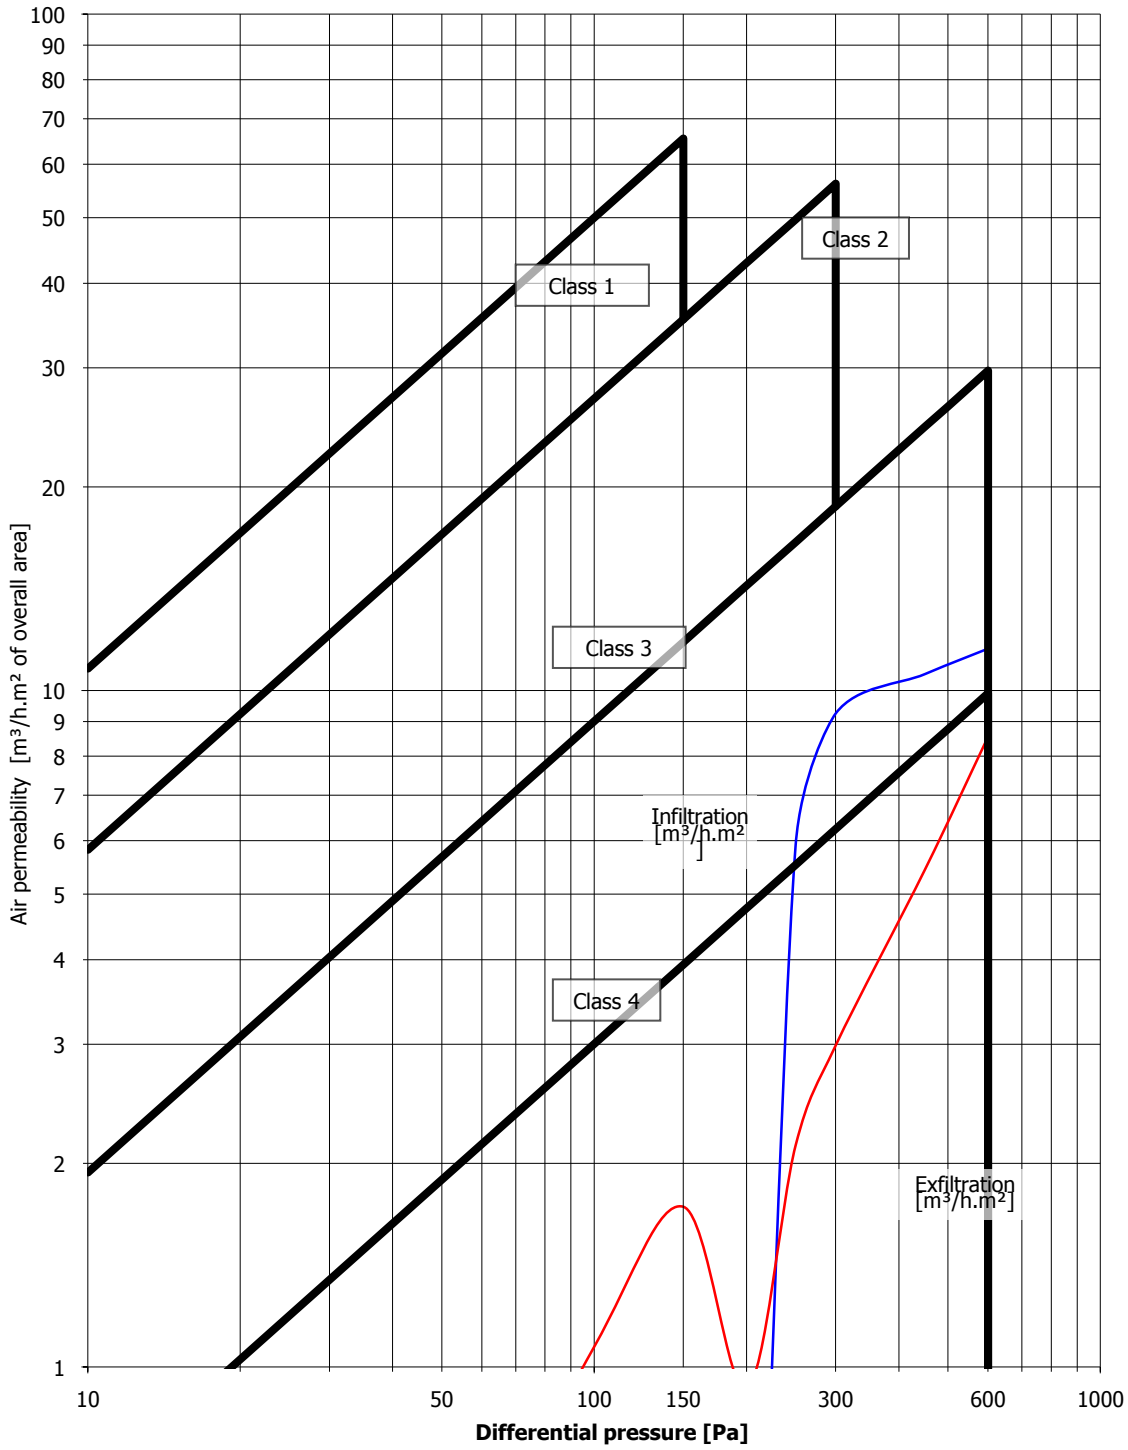
**GRAPH OF AIR PERMEABILITY AFTER GUSTING**

Air Pressure [Pa]	Average rate of air leakage [m <sup>3</sup> /h]	Average rate of air leakage relative to area of sample [m <sup>3</sup> /h.m <sup>2</sup> ]
50	7.7	1.2
100	7.5	1.2
150	15.8	2.6
200	21.3	3.4
250	33.0	5.3
300	40.0	6.4
450	47.9	7.7
600	60.5	9.8

Note: The figures in the table above give the leakage as an average of the leakage at positive pressure and the leakage at negative pressure

In accordance with BS 6375-1:2009 Clause 6.5, as the classification after the resistance to wind load tests is the same as the classification before the resistance to wind load tests, the resulting classification for the sample is Class 3.

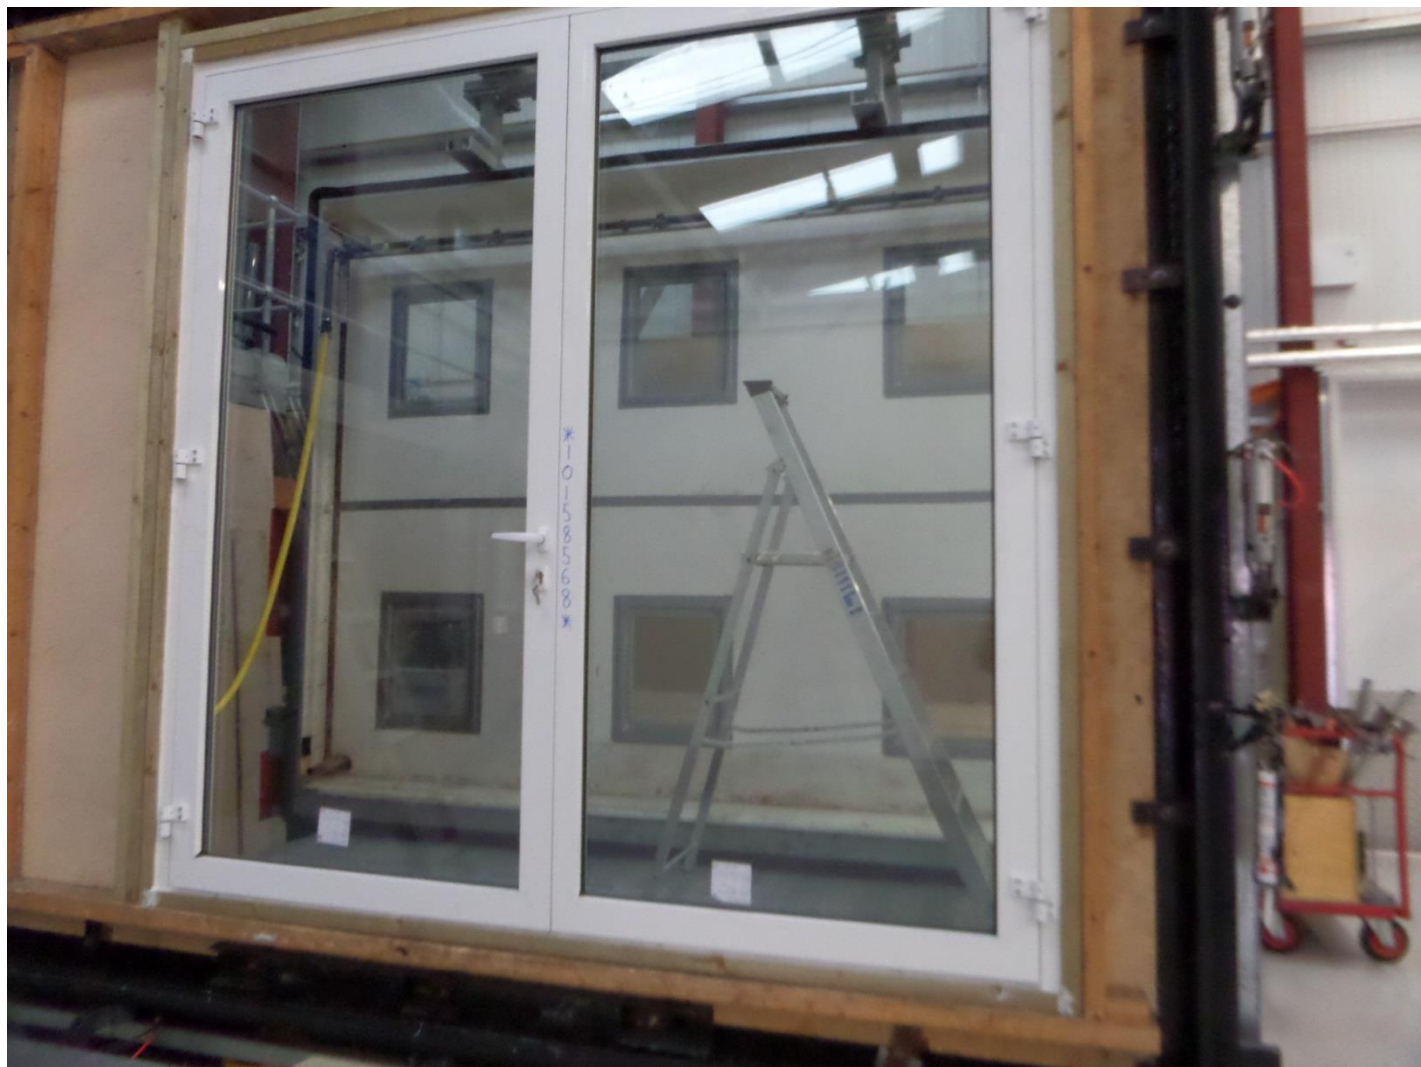
Photograph of Sample.

Description of Sample. (sample 4)

<b>Sample type -</b>	Double leaf open in glaze in door assembly with full glass infill and standard threshold	
<b>Profile codes -</b>	OUTER FRAME - EF415. SASH - EF424. MEETING STILE - EF425. GLAZING BEAD - GL526. COVER PROFILE = EF422. BRUSH CARRIER - EF472. LOW THRESHOLD - EF493. THRESHOLD INSERT - VR023A	
<b>Material -</b>	Aluminium alloy	
<b>Finish -</b>	Painted white	
<b>Fittings -</b>	<p><b>Master leaf</b>          A seven point Sobinco Multipoint (D KT) key locking hardware (two hook bolts/bolts, two dead bolts and one hook bolt) Sobinco cylinder, Fapim handle and three Fapim lift off hinges</p> <p><b>Slave leaf</b>          A two point finger operated hardware (two shoot bolts), three lift off hinges</p>	
<b>Weathersealing -</b>	Double sealed plastic weather-strip	
<b>Glass -</b>	Double glazed with 6-18-6 mm toughened glass sealed units	
<b>Panel -</b>	Not applicable	
<b>Glass retention system -</b>	Internal beads and gasket

<b>Sample dimensions -</b>	Overall - Length: 2480mm Active Leaf - Length: 1250mm Slave Leaf - Length: 1180mm	Height: 2500mm Height: 2400mm Height: 2400mm
<b>Date of test -</b>	15 December 2015	
<b>Laboratory temperature -</b>	19.6 °C	
<b>Laboratory humidity -</b>	48.9 %

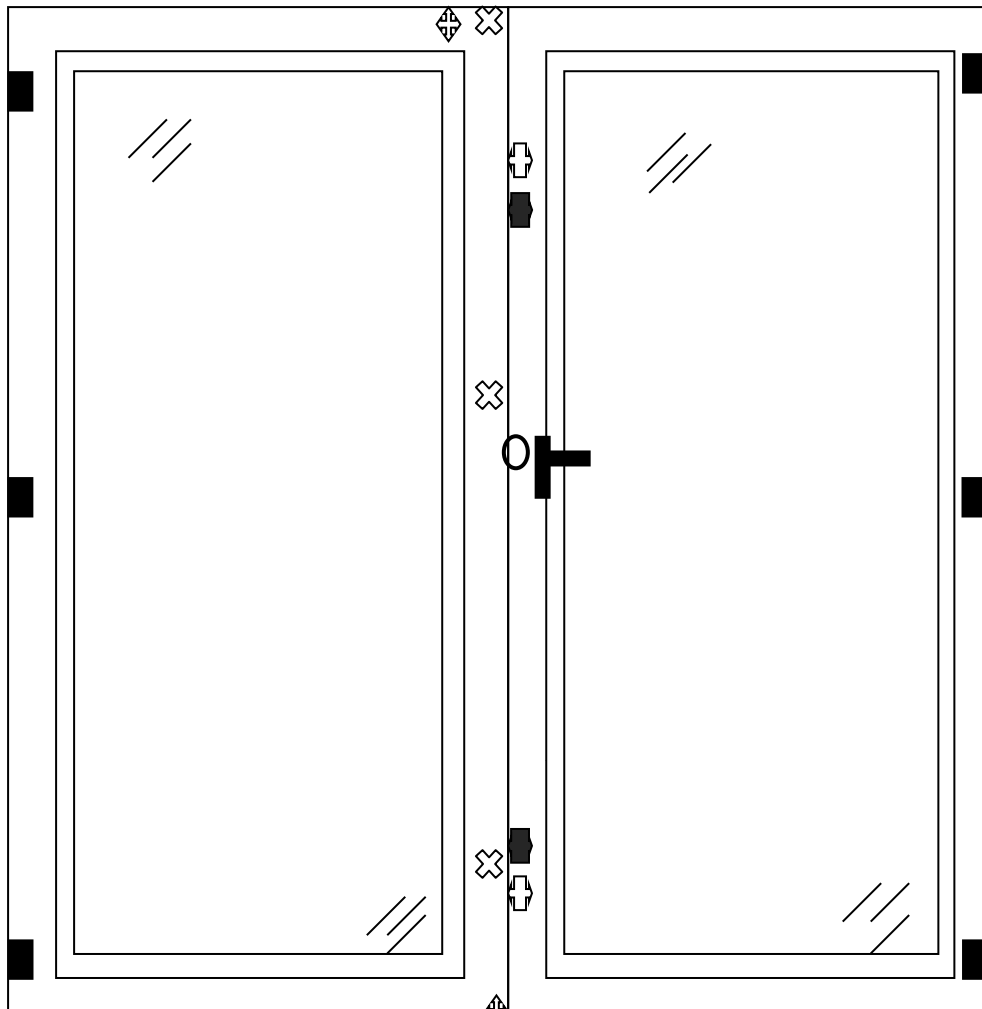
**ELEVATION DRAWING OF DOOR ASSEMBLY  
(indicating position of hardware)**

- Hook bolt / Dead bolt
- Water Leakage

Air pressure (Pa)	Point at which water leakage occurred
300	water ran out and over from the threshold opening joint (false mullion)

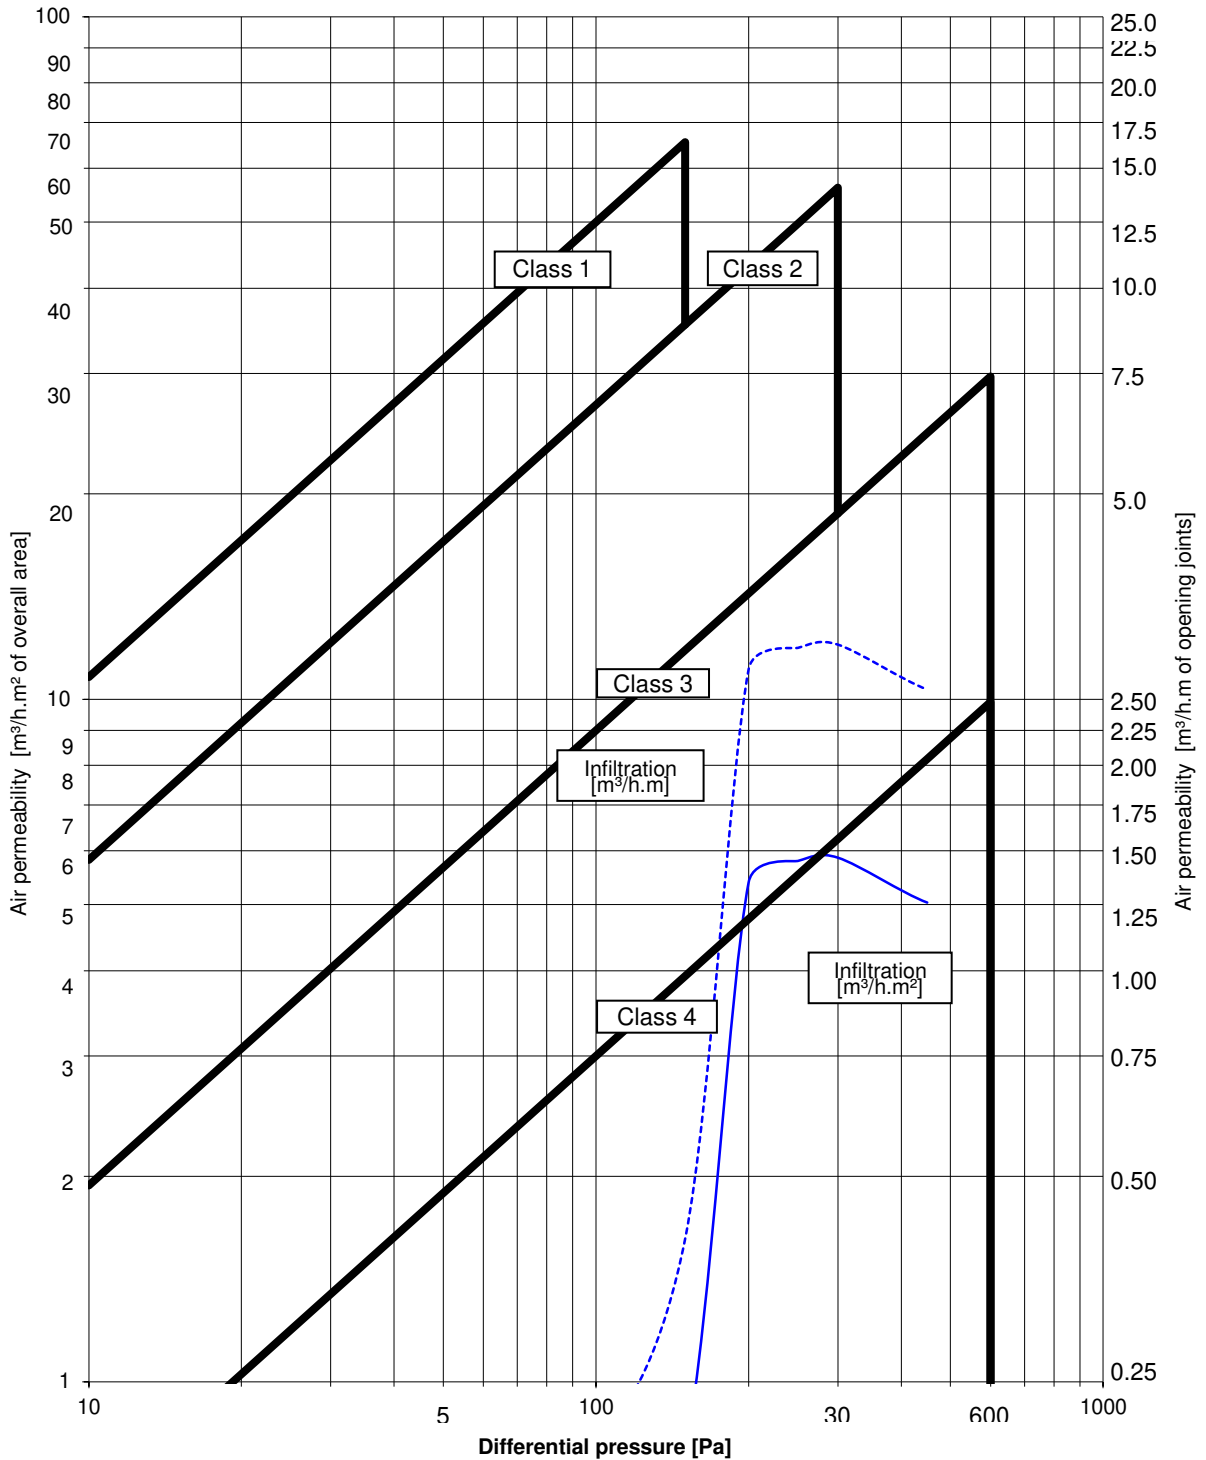
GRAPH OF AIR PERMEABILITY BEFORE GUSTING

Air Pressure [Pa]	Average rate of air leakage [m <sup>3</sup> /h]	Average rate of air leakage per meter length of opening joint [m <sup>3</sup> /h.m]	Average rate of air leakage relative to area of sample [m <sup>3</sup> /h.m <sup>2</sup> ]
50	6.1	0.51	1.00
100	2.9	0.24	0.47
150	2.4	0.20	0.40
200	16.4	1.38	2.70
250	17.7	1.49	2.90
300	18.1	1.52	2.96
450	15.5	1.30	2.53
600	14.8	1.24	2.42

Note: The figures in the table above give the leakage as an average of the leakage at positive pressure and the leakage at negative pressure

BS 6375-1:2009 Clause 6.2 - Overall class = 4

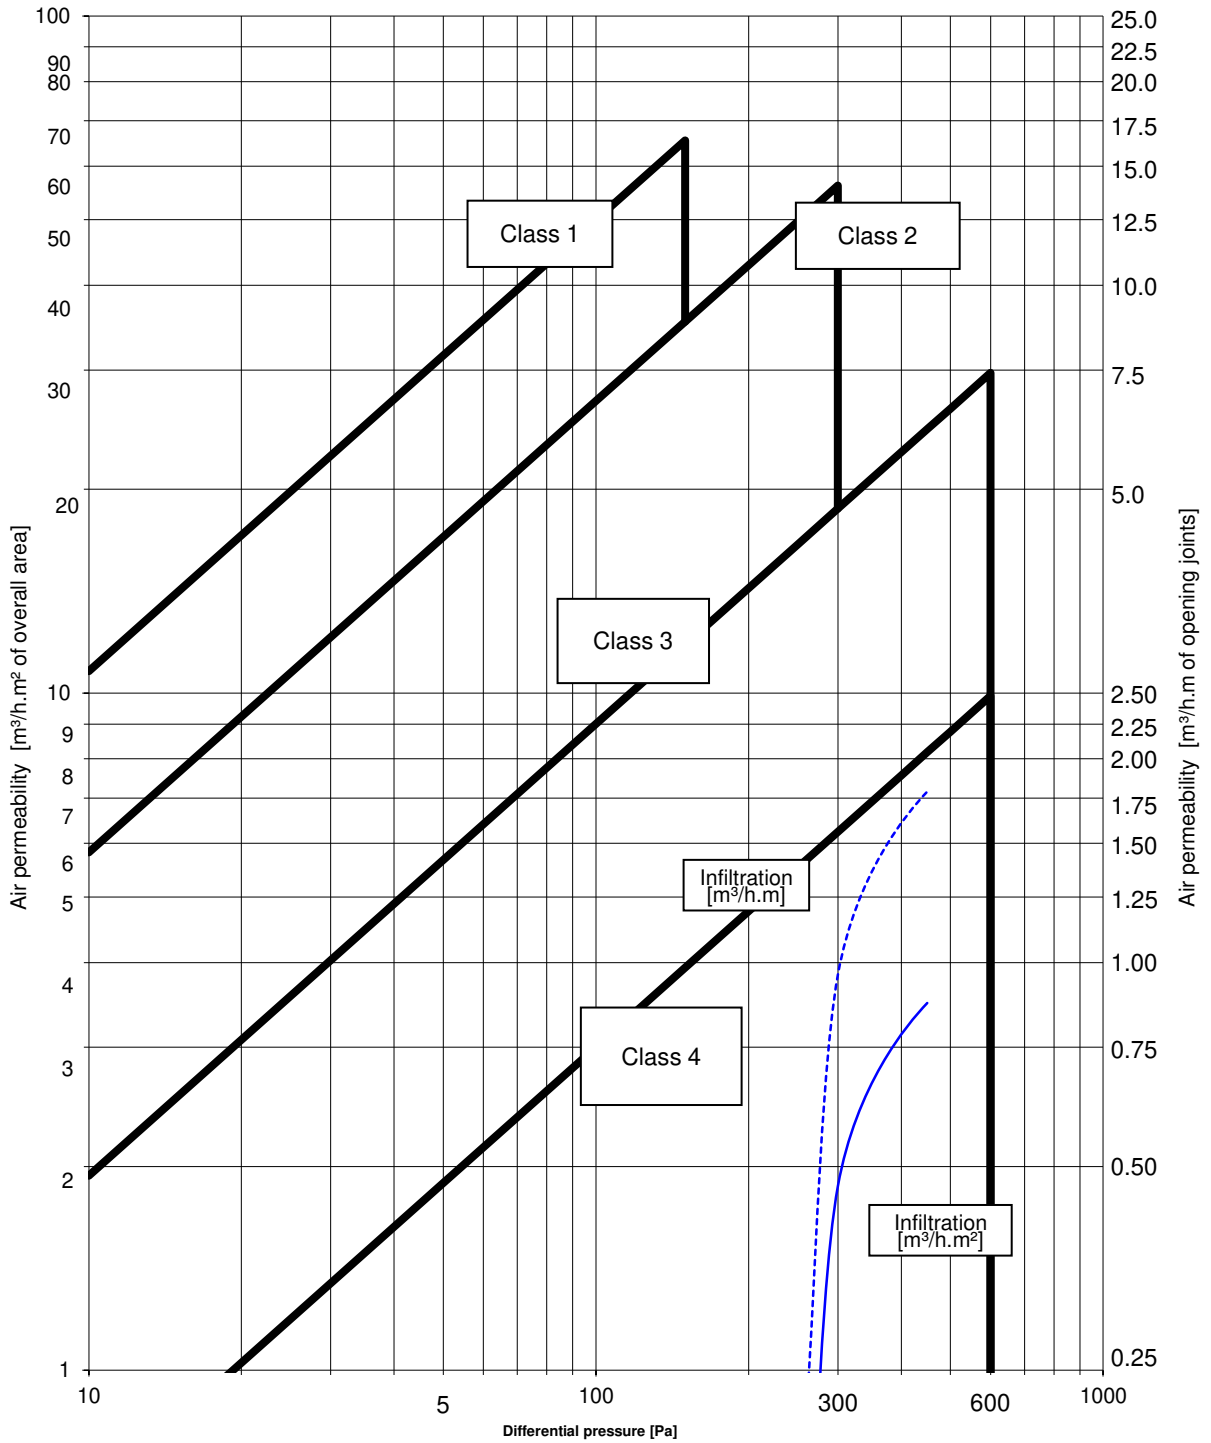
GRAPH OF AIR PERMEABILITY AFTER GUSTING

Air Pressure [Pa]	Average rate of air leakage [m <sup>3</sup> /h]	Average rate of air leakage per meter length of opening joint [m <sup>3</sup> /h.m]	Average rate of air leakage relative to area of sample [m <sup>3</sup> /h.m <sup>2</sup> ]
50	1.4	0.12	0.23
100	1.3	0.11	0.22
150	0.1	0.01	0.02
200	1.0	0.08	0.16
250	1.4	0.12	0.23
300	6.1	0.51	1.00
450	11.0	0.93	1.81
600	11.8	0.99	1.93

Note: The figures in the table above give the leakage as an average of the leakage at positive pressure and the leakage at negative pressure

In accordance with BS 6375-1:2009 Clause 6.5, as the classification after the resistance to wind load tests is the same as the classification before the resistance to wind load tests, the resulting classification for the sample is Class 4.

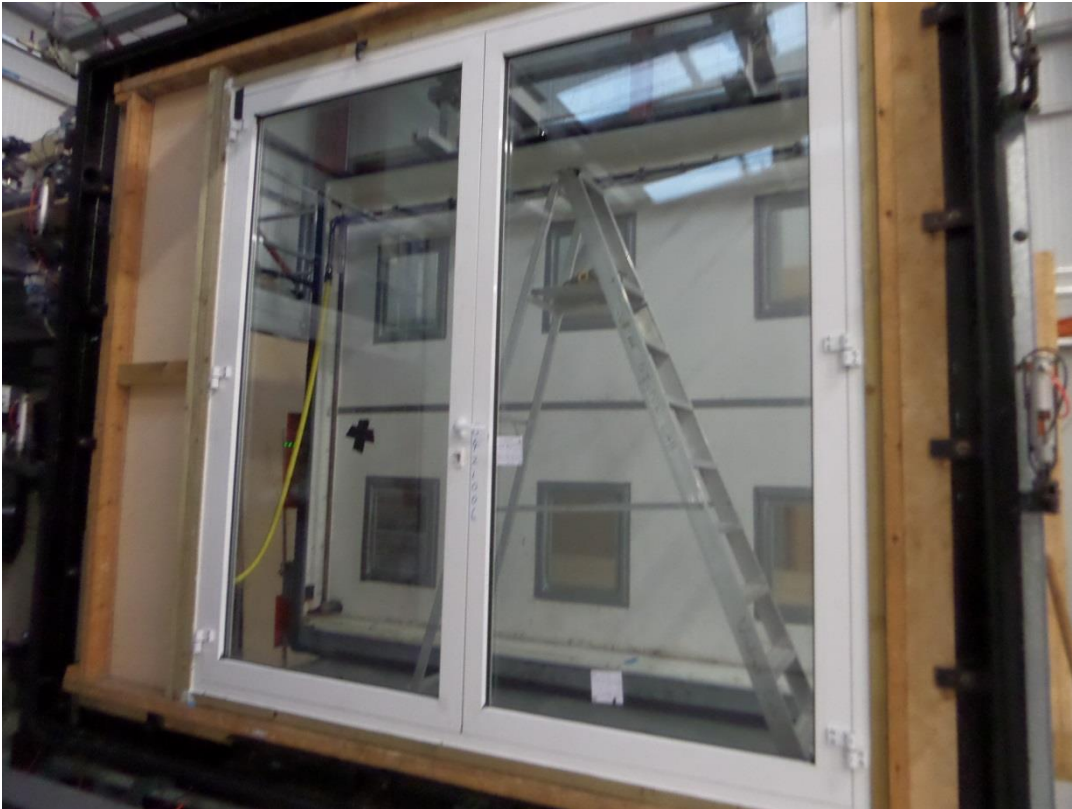
Photograph of Sample.

Description of Samples. (sample 5)

<b>Sample type -</b>	Double leaf open out glaze in door assembly with full glass infill and standard threshold		
<b>Material -</b>	Aluminium alloy		
<b>Finish -</b>	Painted white		
<b>Fittings -</b>	<p><b>Master leaf</b> A seven point Sobinco Multipoint (D KT) key locking hardware (two hook bolts/bolts, two dead bolts and one hook bolt) Sobinco cylinder, Fapim handle and three Fapim lift off hinges</p> <p><b>Slave leaf</b> A two point finger operated hardware (two shoot bolts), three lift off hinges</p>		
<b>Weathersealing -</b>	Double sealed plastic weather-strip		
<b>Glass -</b>	Double glazed with 6-16-6 mm toughened glass sealed units		
<b>Panel -</b>	Not applicable		
<b>Glass retention system -</b>	Internal beads and gasket		
<b>Sample dimensions -</b>	Overall -	Length: 2480mm	Height: 2500mm
	Active Leaf -	Length: 1250mm	Height: 2400mm
	Slave Leaf -	Length: 1180mm	Height: 2400mm
<b>Date of test -</b>	16 December 2015

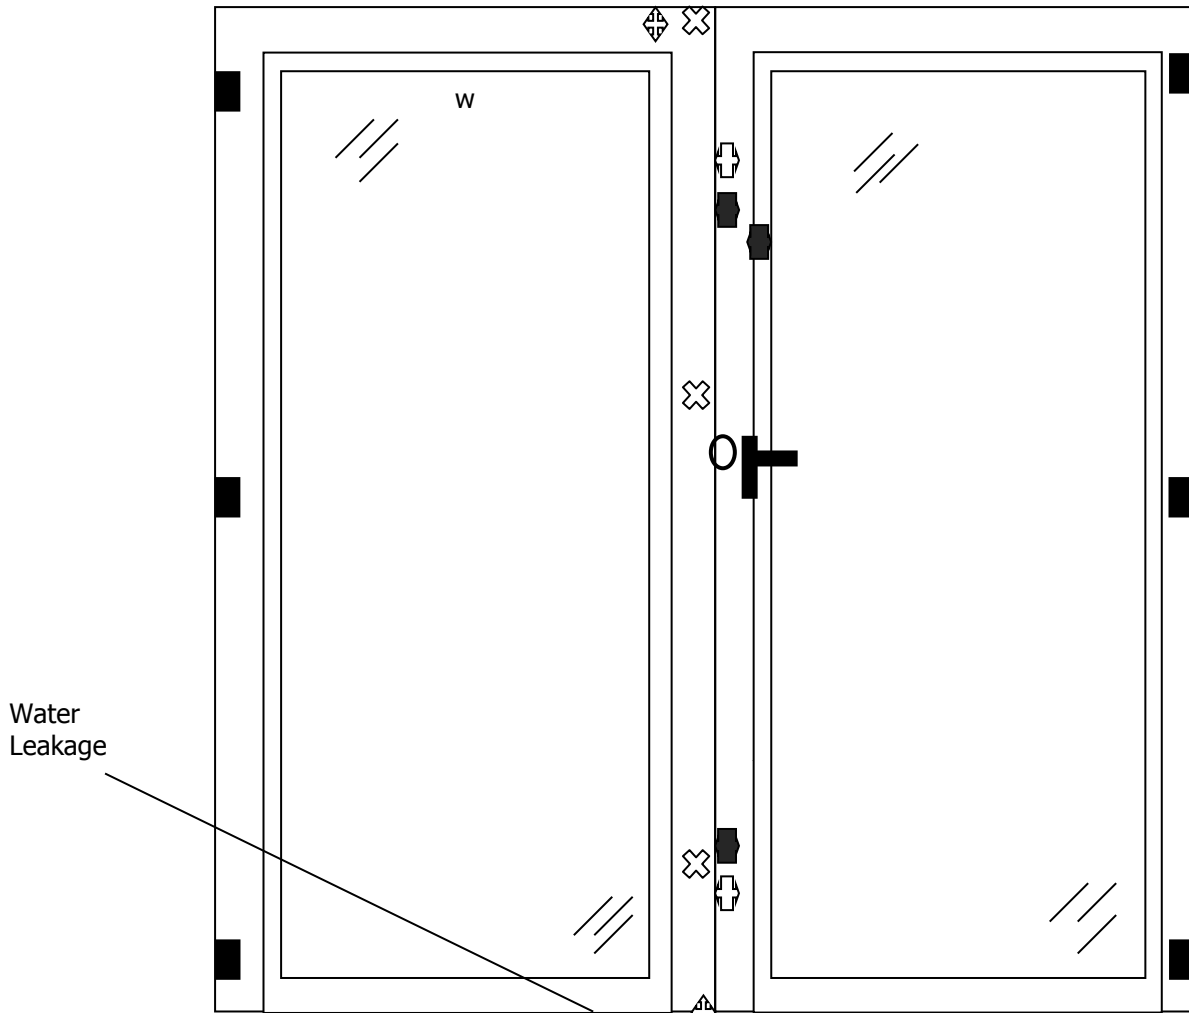
**ELEVATION DRAWING OF DOOR ASSEMBLY  
(indicating position of hardware)**

Water Leakage

- Hook bolt / Dead bolt

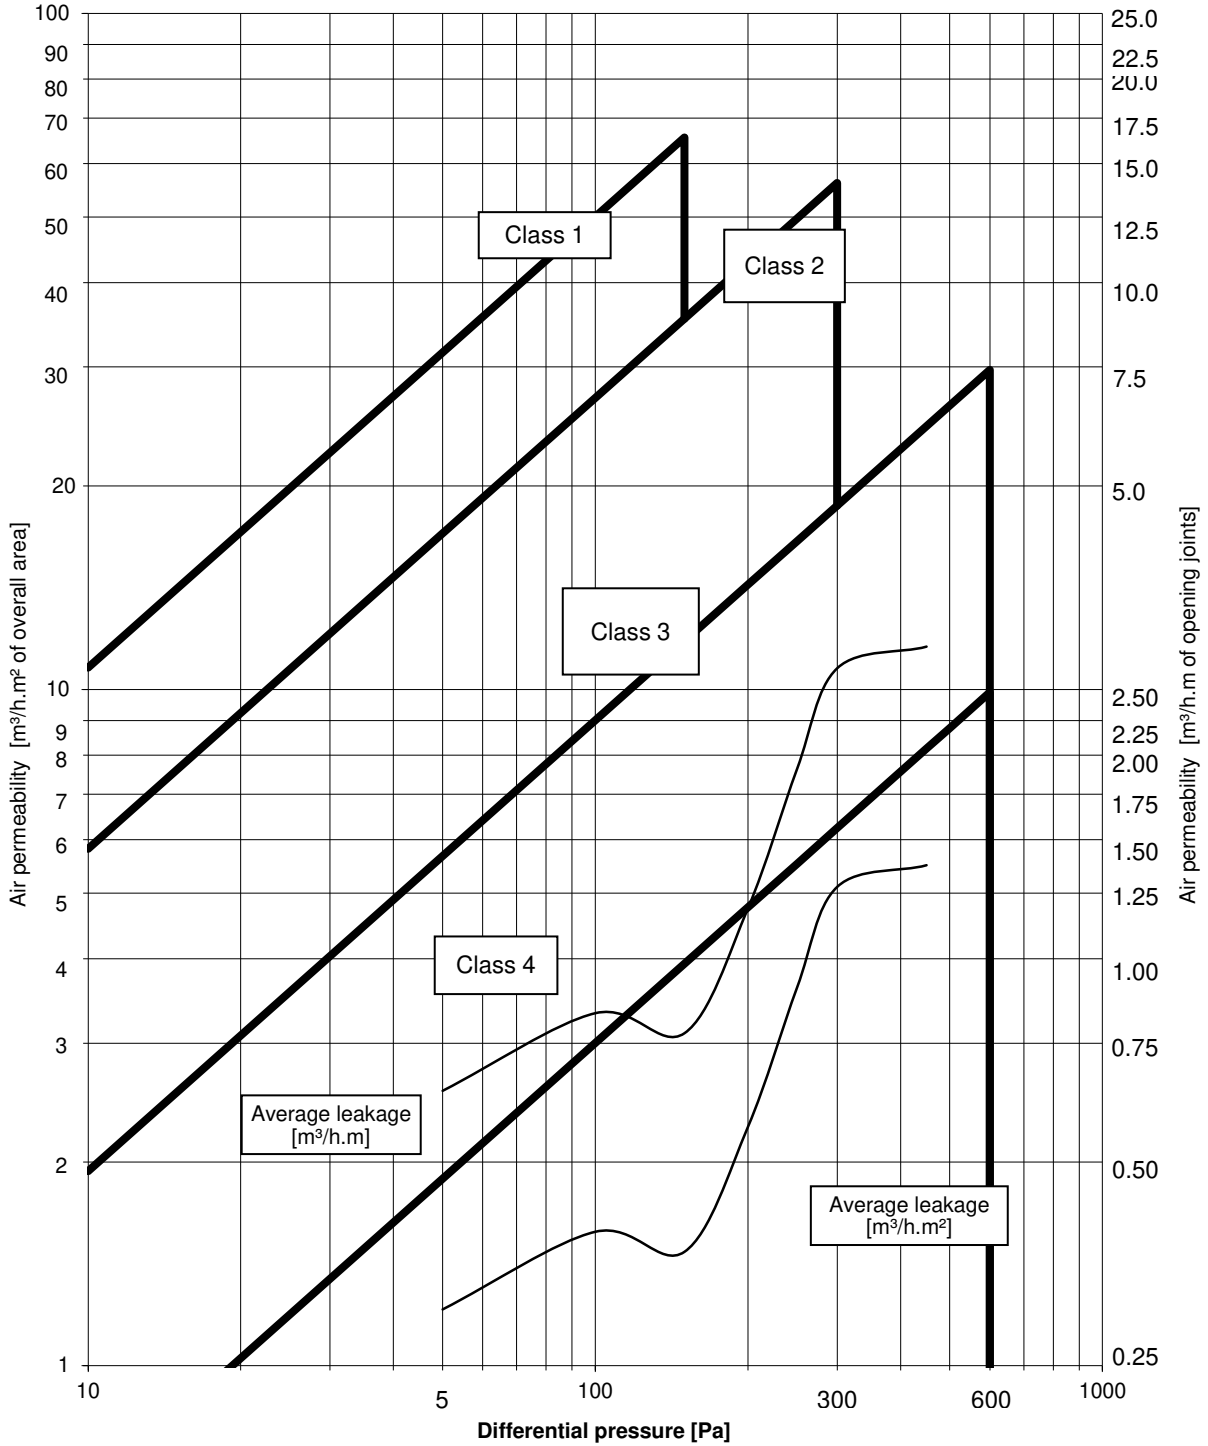
GRAPH OF AVERAGE AIR PERMEABILITY

Air Pressure (Pa)	Average rate of air leakage [m <sup>3</sup> /h]	Average rate of air leakage per meter length of opening joint [m <sup>3</sup> /h.m]	Average rate of air leakage relative to area of sample [m <sup>3</sup> /h.m <sup>2</sup> ]
50	7.5	0.64	1.21
100	9.8	0.83	1.58
150	9.1	0.78	1.47
200	14.0	1.19	2.26
250	22.5	1.91	3.63
300	31.7	2.69	5.11
450	34.1	2.89	5.50
600	36.8	3.12	5.94

Note: The figures in the table above give the leakage as an average of the leakage at positive pressure and the leakage at negative pressure
