**Testing of Smart
Architectural Aluminium
Limited's Visofold 1000
folding doorset to the
requirements of Annex
A and B of PAS 24:2012**

Smart Architectural Aluminium
Limited
Arnold's Way
Yatton
Bristol
North Somerset
BS49 4QN

Test report number 292871

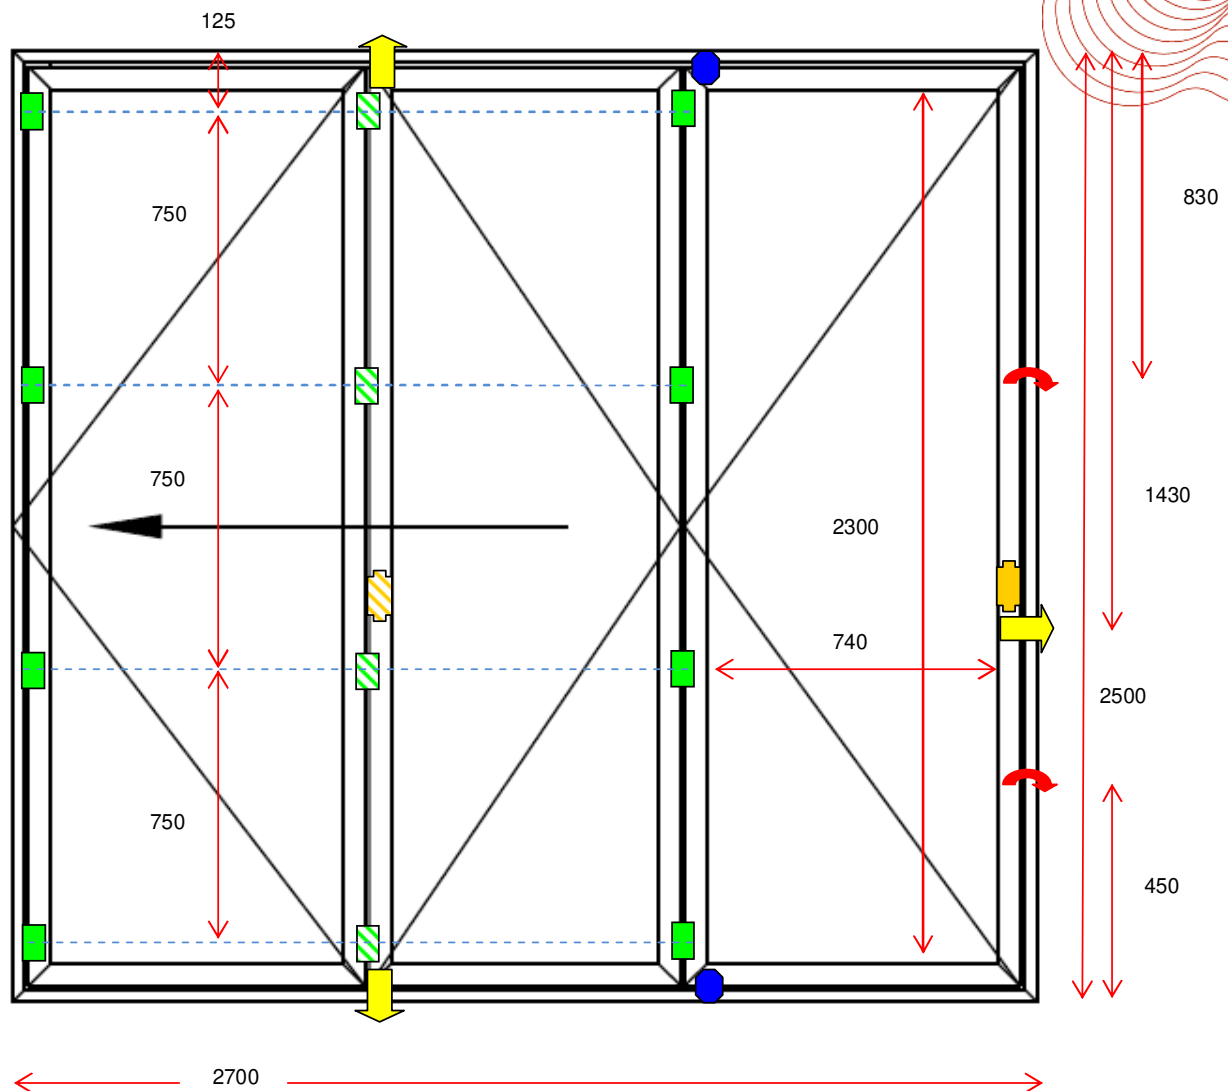
Figure 1 Specimen 292871/01 (external view)

-   Hook bolt
-   Hinge (Internal face)
-   Hinge
-   Key lock (Internal face)
-   Key and handle
-   Deadbolt/shootbolt
-   Hinge bolt
-   Locking cam

All dimensions in mm

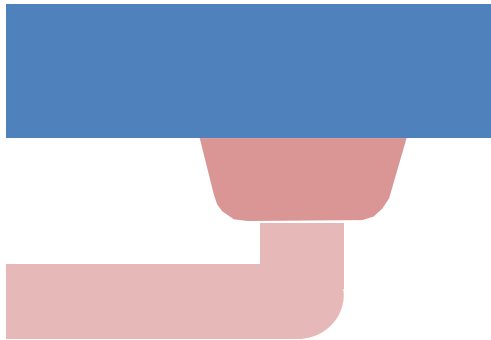
Specimen 292871/02 was identical to specimen 292871/01 with the exception of the handle set. The apparent difference between the handle sets was their horizontal cross sectional profile. The cross-sectional profiles are shown below. The client advised the incorrect handle set was installed on specimen 292871/02.

Horizontal cross-section of handle set on specimen 292871/01

* This is based on the doorset being fitted with a handle set identical to that incorporated on specimen 292871/01.

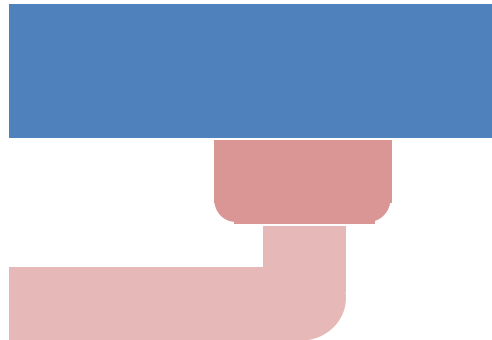
Horizontal cross-section of handle set on specimen 292871/02
