**Test Report 8247857.**  
Smart Systems Limited  
incorporating Smart Extrusions

Type test for product certification

Smart Visiglide Plus aluminium sliding patio doors

PAS24/BS4873 Type test

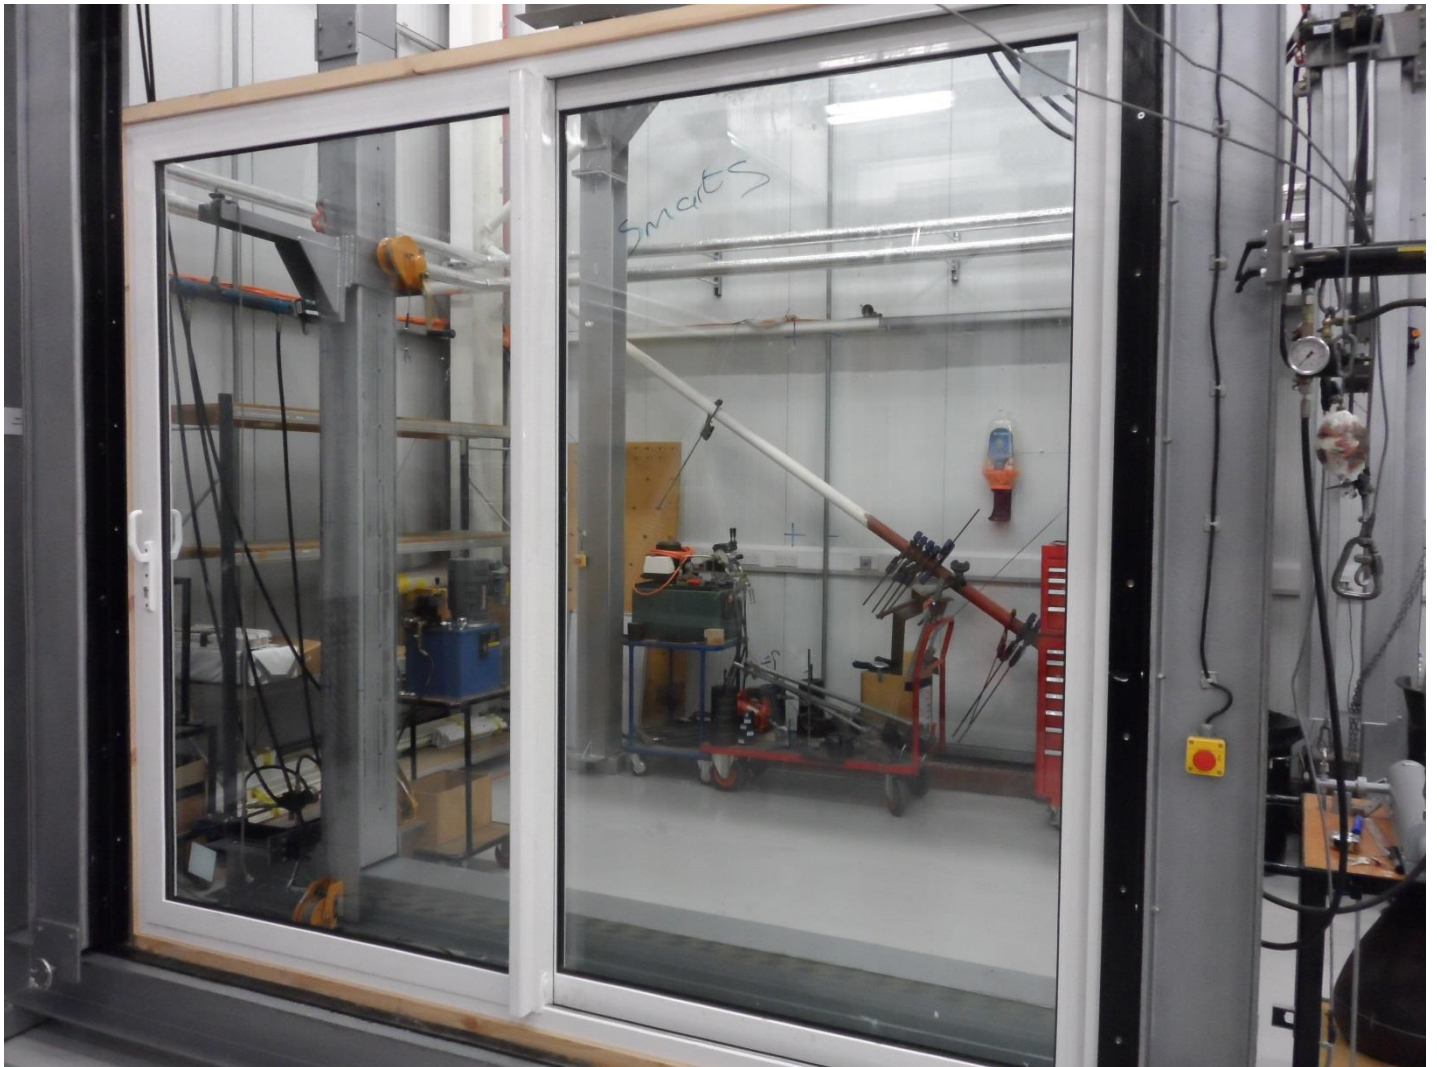
Photograph of Sample.

1 off sliding patio door with one fixed pane and two sliding panes fully glazed in door assembly with standard threshold
