Test Report 3251300.
Smart Systems Limited
Incorporating Smart Extrusions

Job/Registration Details	Client Details
Job number: 3251300 Job type: Testing Samples Submitted Start Date: 27/07/2020 Test type: Direct Sample ID: 10191178 Registration: NA Protocol: NA Quality system: NA Registration: NA Protocol: NA Quality system: NA	Smart Systems Limited Incorporating Smart Extrusions Arnolds Way Yatton BS49 4QN United Kingdom

Alitherm Heritage double doors

BS7412:2007 Weather Type Test.

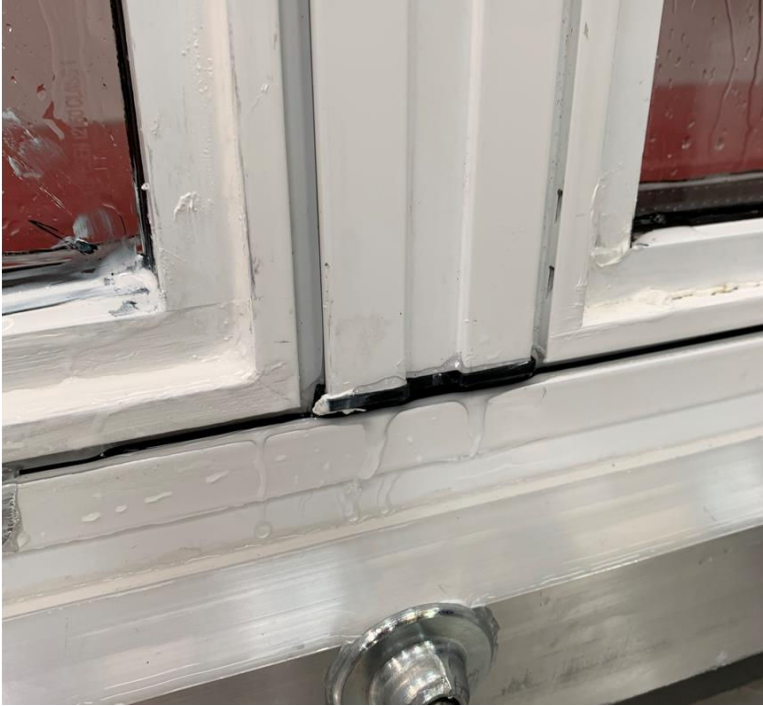
Photograph of Sample.

Sample Description
1 off double leaf open in glaze in hinged door assembly with glass above and below the midrail with a standard threshold
1 off double leaf open out glaze in hinged door assembly with glass above and below the midrail with a standard threshold
