Test Report 8420999.
Smart Systems Limited
Incorporating Smart Extrusions

Type Test for Product Certification

Smart Systems Eco Futural Aluminium Alloy Windows

BS4873:2009 Weather Type.

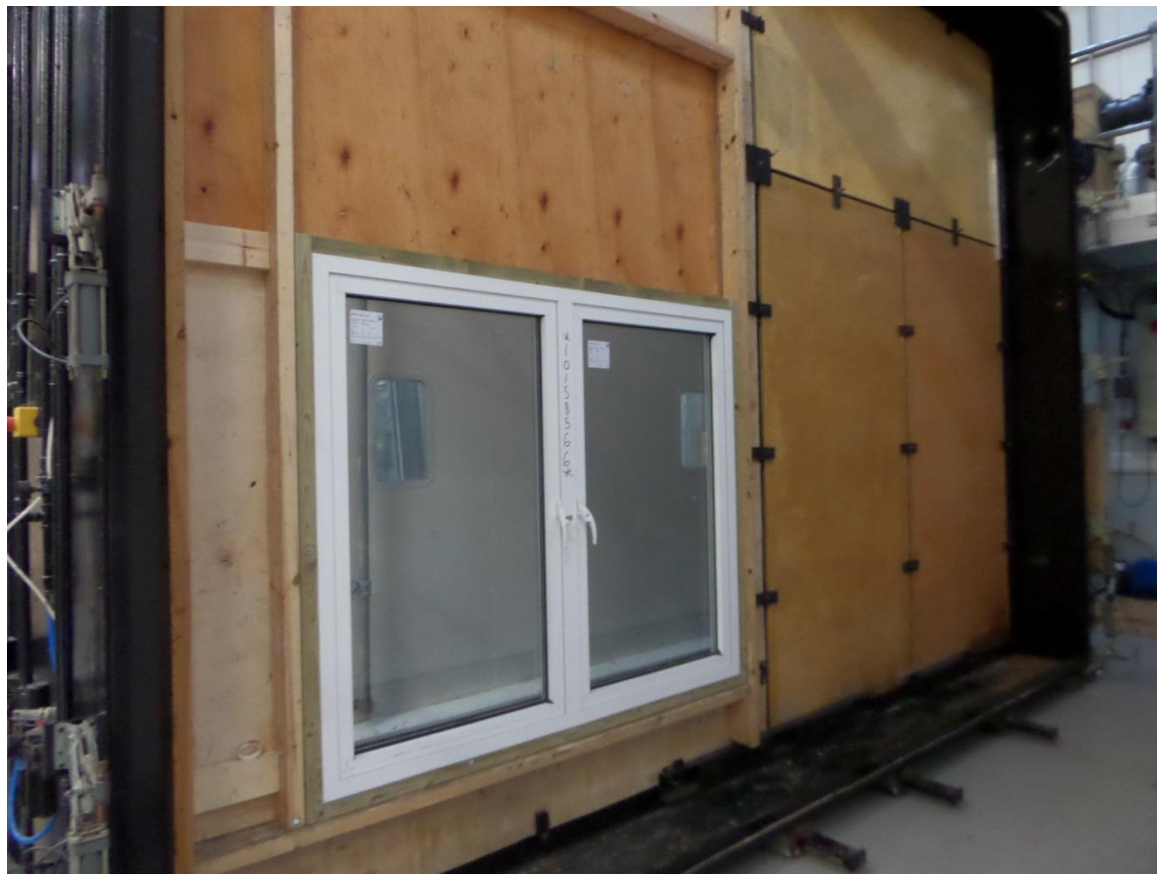
Photograph of Sample.(sample 1)

Manufacturer -	Smart Systems
Window type -	Projecting side hung next to projecting side hung
Material -	Aluminium
Finish -	White
Construction -	Outerframe: Cleated Sash: Cleated
Fittings (Each sash) -	Hinge: 16" Securistyle side hung stays Locking: A six point locking (six mushroom bolt) ERA locking system operated by a key locking handle 5 off run up blocks 2 of pairs of Vector hinge protectors
Glass -	Double glazed, 6-18-6mm toughened glass sealed units
Glazing system -	Internal beads and gaskets
Sample dimensions -	For information only (nominal sizes) Overall size Length: 1730mm Height: 1440mm Each sash size Length: 840mm Height: 1410mm
Date of test -	16 December 2015
Laboratory temperature -	18.6°C
Laboratory humidity -	48.4%
Atmospheric pressure:	100.1kPa

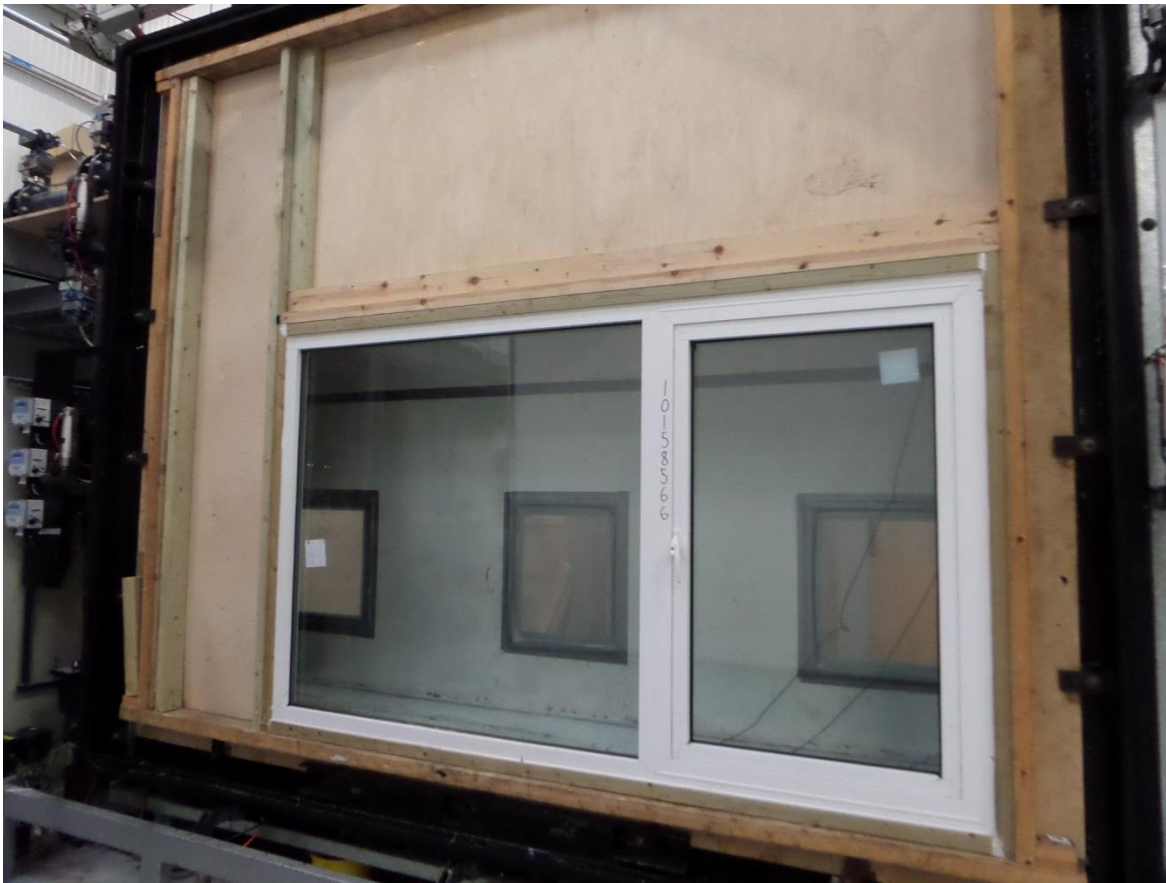
Photograph of Sample.(sample 3)

Manufacturer -	Smart Systems	
Window type -	Projecting side hung next to fixed window	
Material -	Aluminium	
Finish -	White	
Construction -	Outerframe:	Cleated
	Sash:	Cleated
Fittings -	Hinge:	16" Securistyle side hung stays
	Locking:	A six point locking (six mushroom bolt) ERA locking system operated by a key locking handle
Glass -	Double glazed, 6-18-6mm toughened glass sealed unit	
Glazing system -	Internal beads and gaskets	
Sample dimensions -	For information only (nominal sizes)	
	Overall size	
	Length: 2400mm	Height: 1405mm
	Sash size	
	Length: 840mm	Height: 1345mm
Date of test -	19 December 2015	
Laboratory temperature -	18.6°C	
Laboratory humidity -	44.7%	
Atmospheric pressure:	99.9kPa
